Product Case History

Overcoat of jet fuel tank

Tank NO. 7 Overcoat - Shell Sarnia

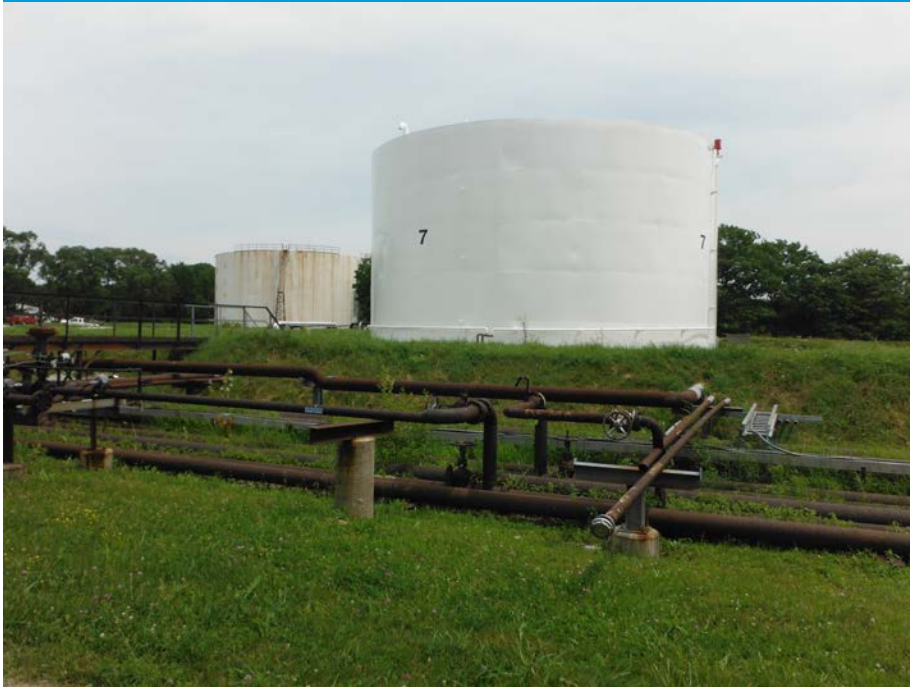
Tank appearance was a problem for the neighborhood. Shell wanted to repair the condition of the tank without having to blast the tank. The original coating was stained for dark marks covering most of the tanks. Carboline coating system covered the tank offering a more pleasant appearance, the client was extremely happy with the outcome.

SURFACE PREP: Water Blast 3000-4000 PSI

PRODUCTS: Rustbond, Carbomastic 615, Carbothane 134 HG
