## Basic Electric-Antelope Valley Station

**Area Coated: Exterior Coating**

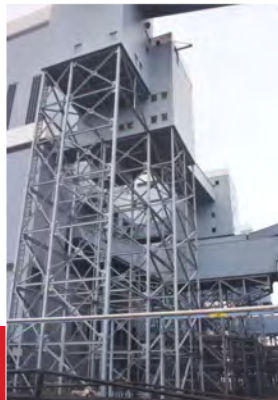
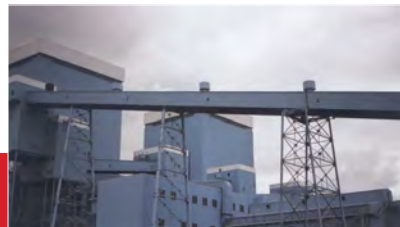
- First Coat: Rustbond
- Second Coat: Carbomastic 15
- Third Coat: Carbothane 133 HB

This job included several different aspects: conveyors, air vents, and a bag house.

The customer was extremely impressed with how well Rustbond was able to adhere to the old coating.
