Peabody Conveyor

Area Coated: Exterior Coating

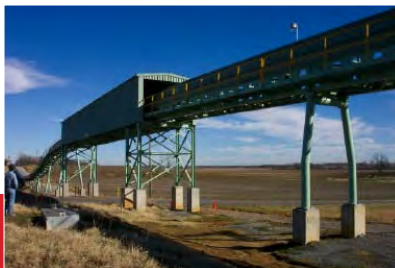
There were several problems concerning this conveyor. The steel supports and overpasses were heavily rusted, it was previously coated with lead paint, and vinyl covered 50% of the surface. In order to handle the difficulties, most of the units were disassembled and taken to a prep plant in Southern Illinois. They were clean and coated. Then the ready to assemble pieces were shipped back to the site.

- First Coat: Rustbond Penetrating Sealer WG
- Second Coat: Carbothane 133 HB
