Product Case History

Des Moines Bridge Repaint

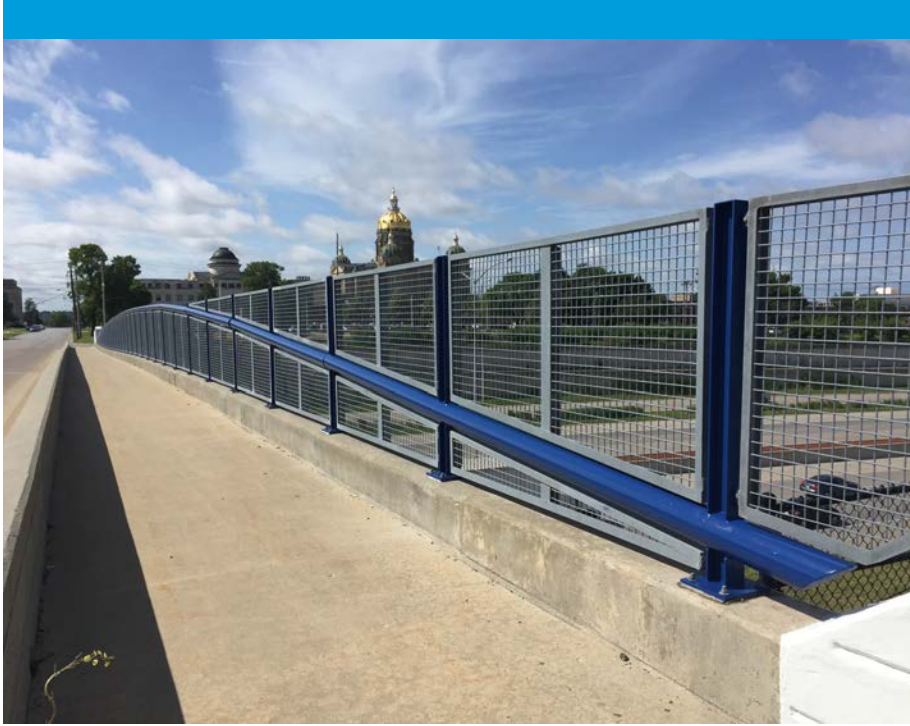
This project was an overcoat of an existing finish. The existing finish was beginning to chalk and fade.

First coats was a spot prime of all bare areas with Carbomastic 615. The entire structure was then prepared and coated with Carbothane 133 HB followed by a topcoat of the Carboxane 950.
